AIRWORTHINESS DIRECTIVE

TYPES AFFECTED: Pilatus B4 gliders all models all serial numbers

SUBJECT: Corrections to airspeed limitations.

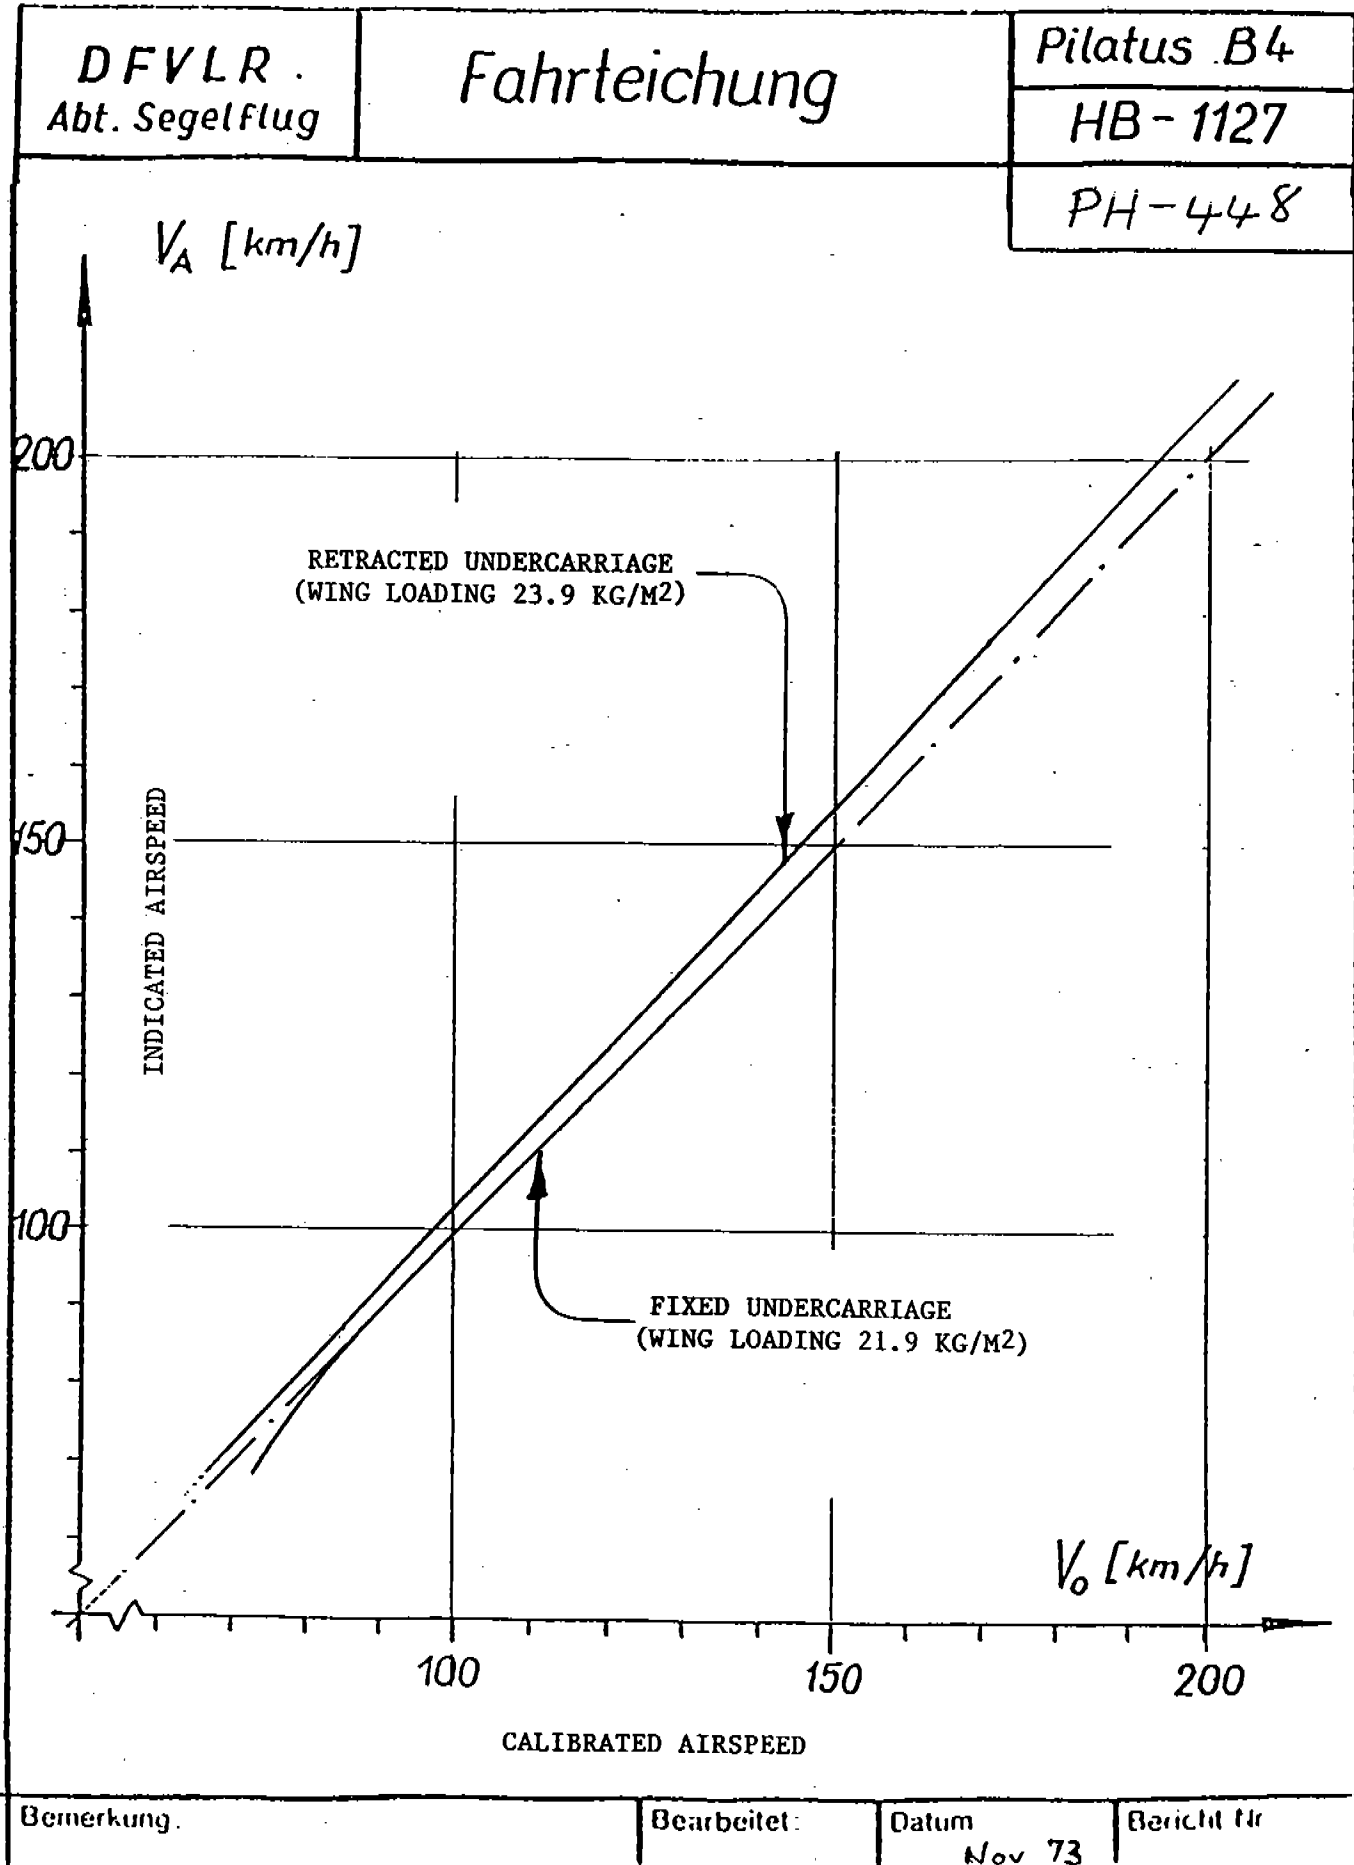
POSITION ERROR DATA PROVIDED BY PILATUS MARCH 1988

- (1) Calibrated Airspeeds stated on Swiss Type Certificate No s 43-02 (31/1/1975)
- (2) Pilatus Position Error Data provided March 1988 (reproduced overleaf)
