GLIDING FEDERATION OF AUSTRALIAAIRWORTHINESS DIRECTIVE GLIDERS/POWERED SAILPLANES GFA/AD 208 GROB 19GLIDER/POWERED SAILPLANE TYPE AFFECTED: GROB ASTIR CS
All Serial Nos. 1001 to 1536SUBJECT: Replacement of Tailplane leading edge spherical locking bolt.AUTHORITY: Mandatory change requested by manufacturer under TM-306-17 Instruction 1.BACKGROUND: Spherical Locking bolt.
Cracks have been detected in the threaded section which was a cut thread, not a rolled thread, in the original bolt.REQUIRED ACTION:(1) Before next flight -

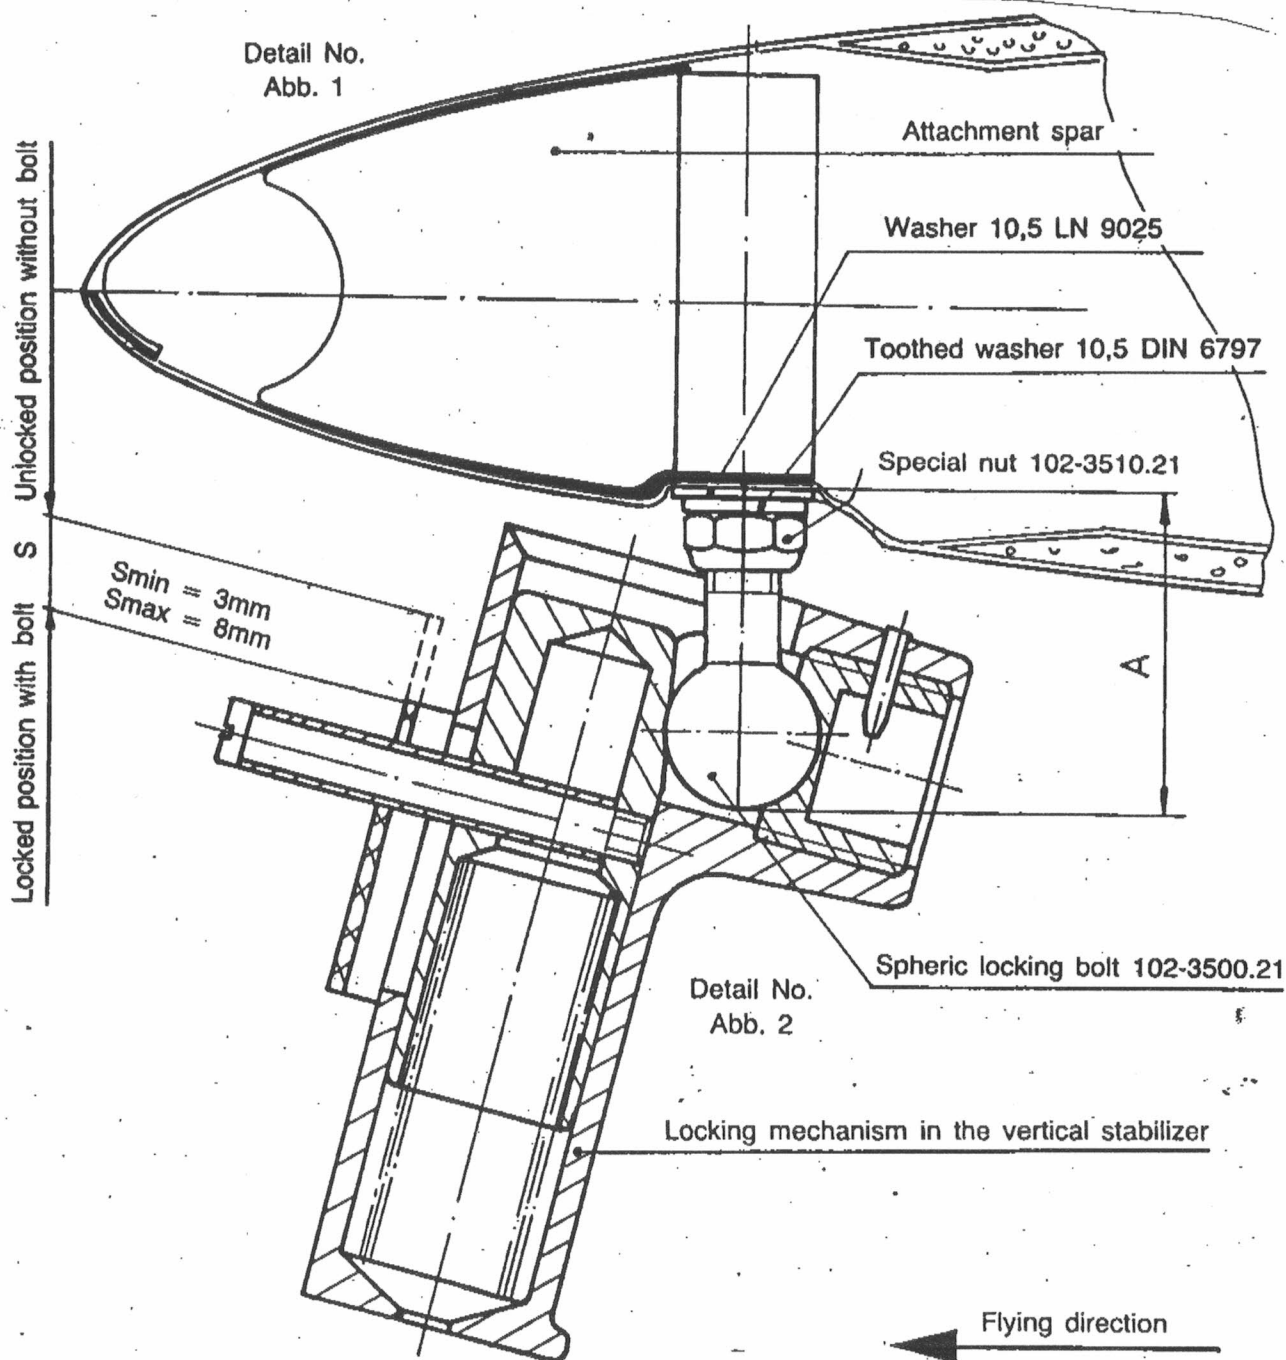
- Mount the modified locking bolt (102-3500.21) with a toothed washer 10,5(DIN 6797 phr) and the nut (102-3510.21) according to detail No. 1. Adjust the bolt to the correct installation depth (A) and lock it by holding the ball with the screw-driver and tightening the nut with the wrench. Afterwards apply a small line of red color from the shaft of the bolt across the nut to the elevator surface to indicate unintentional rotation.

- Mount the tail unit properly and couple the control-rods. Check for safe installation. If the locking-plate in front of the fin moves less than 3 mm (0.12in.) from the "unlock" to the "locked" position the diameter of the ball is too small and not allowable play can be expected. (see detail No.2). A larger locking bolt must be installed.

- Remove the tail unit from the vertical stabilizer.
- Note the installation depth (A) of the used bolt to insure the correct installation of the replacement bolt in order not to change the tailplane angle of incidence.
- Loosen the M10 - nut with the 14 mm wrench.
- Place the screwdriver into the slot of the ball and turn out the bolt.
- The new locking bolt (102-3500.21) has rolled thread and requires a special nut (102-3510.21)
